Preservation & Stabilization of The Hollow, Summer 2009

Prepared October 2009 by local project manager/architectural historian Cheryl H. Shepherd

Representing *Preservation Virginia* & Dr. & Mrs. David C. Collins

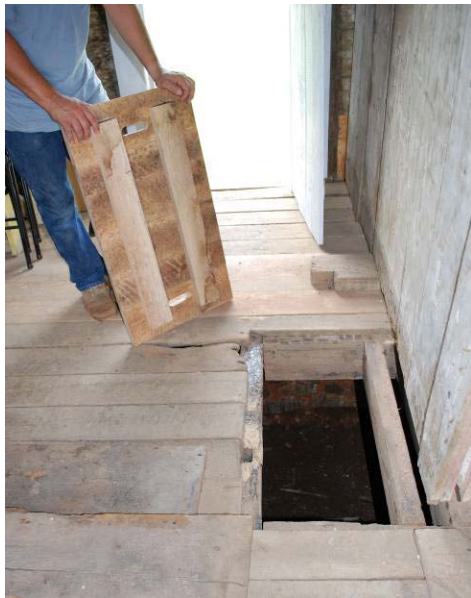
West Hall - Fence boards were inserted in place of unsafe 20th-century boards

Above, Karl begins to insert his just-built cellar door that will set flush within the existing floor opening. This replaced the oversized board of plywood that haphazardly covered the entrance for many years.

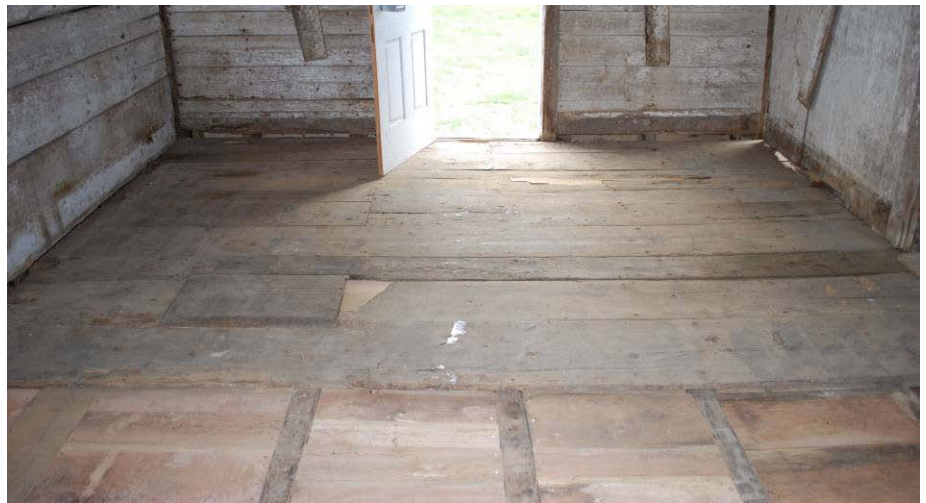
Pictured to the right, Karl and Mike carefully take up the 19th-century floor boards in the east parlor. The lower view shows the floor after they laid boards back into position on the front floor joists that received narrow wood strips on their sides to support reinforcement boards, as shown in the foreground. This strengthening method allowed them to save the old floor boards, even those with large holes. Although now two layers exist, the floor height remains the same, and the door swings easily open. Scholars can still read the tool marks and nail evidence in the preserved 19th-century floor in this room.

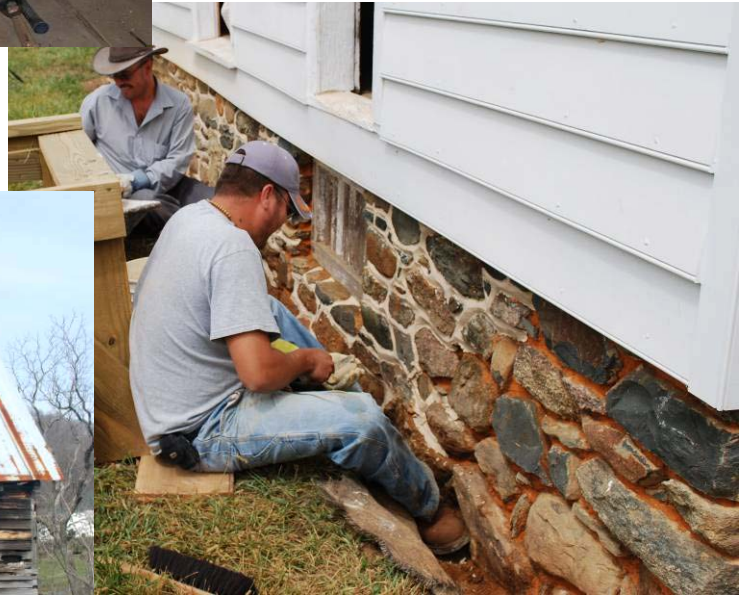
In September, Edward had stonemasons Miguel and Alejandro tuck pointing lime putty mortar to the foundation. Plywood shades this material for slow curing.
