Preservation & Stabilization of The Hollow, Summer 2009

Prepared October 2009 by local project manager/architectural historian Cheryl H. Shepherd

Representing *Preservation Virginia* & Dr. & Mrs. David C. Collins

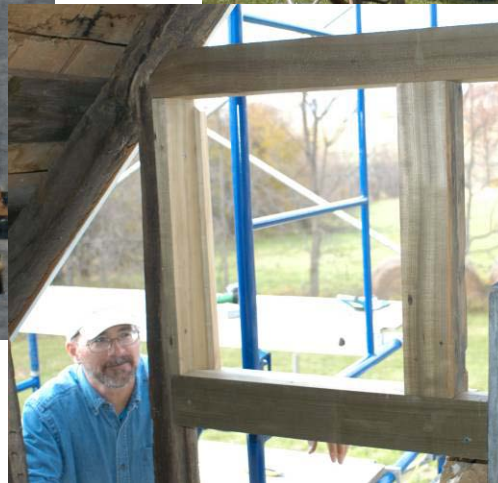
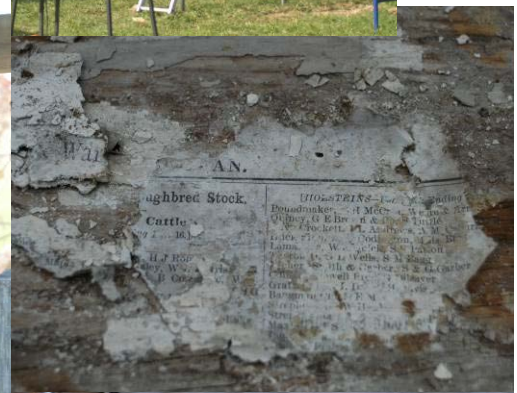
Last year, Karl, shown above finishing his beaded northwest-rear window frame, and Mike, at right after inserting his window frame to receive a four-light casement beside the west chimney on the 2nd-floor, prepared the walls for beaded poplar weatherboards. This required repair of existing window and door frames, such as the back-door frame with consolidation drying at lower right, or restoration of missing frames. Early tenants applied whitewash over *The Warrenton Virginian* newspaper to insulate cracks between boards on a board-and-batten door that Karl installed for the rear entrance. Newspaper also remains under whitewash on the partition between the hall and parlor inside the dwelling. A report on Thoroughbred Stock cattle on the door is pictured at center right. Meticulous removal of layers of lime wash to consolidate the door produced only one date, 1886, indicating that the application occurred or post-dated that year. Boards feature both watermill-sawn and circular-sawn marks of earlier creation and later repair. Unfortunately and similarly to archaeological evaluation, removal to date the interior lime wash and newspaper compromises integrity of these artifacts and future educational plans for the home. Therefore, scraping for dating information on the partition and other surfaces will not occur.

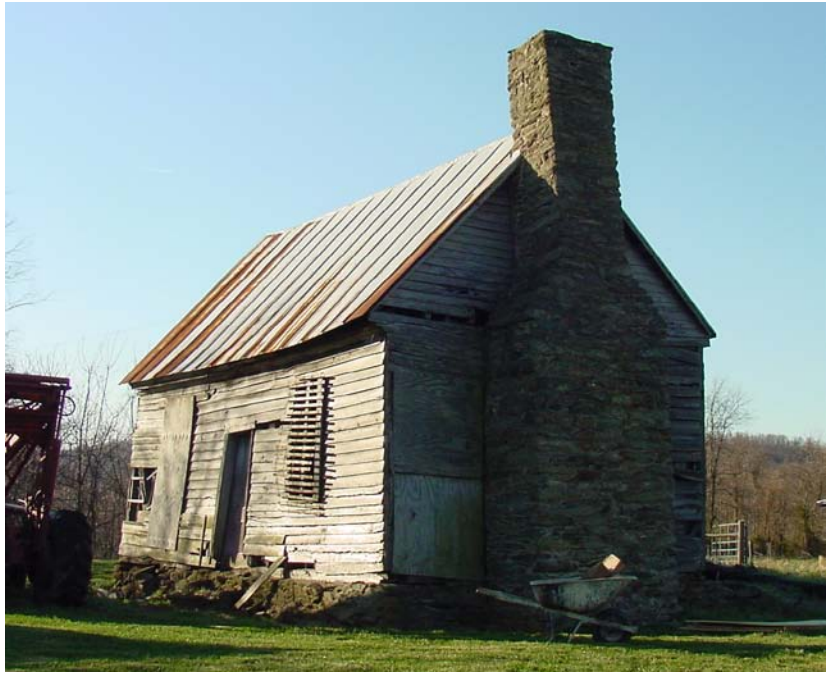
Comparing the façade in March 2004 with August 2009
